**OXNARD CULTURAL HERITAGE BOARD  
STAFF REPORT AND RECOMMENDATIONS  
AGENDA OF MARCH 28, 2011  
ITEM NO. 4a**

Landmark No. 161, 210 South F Street, Oxnard; Exterior and Interior Improvements and Removal of Four Trees, Project No. 11-332, Request for a Certificate of Appropriateness.

## Morrison Mays Landscape Architecture

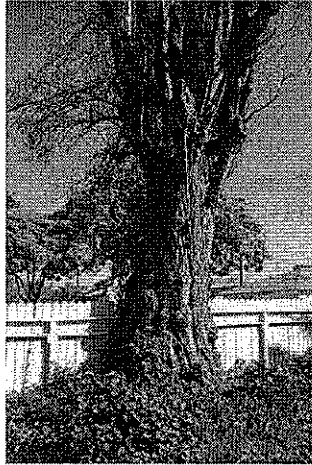
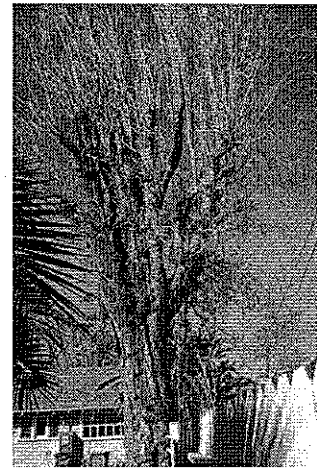
Tree has been topped several years prior. Lion tailing from heading cuts clearly visible. No foliage.

Note the overhead service lines in the foreground - these are not near the tree canopy. The service lines on the adjacent property are also well clear of the canopy.

The tree is clearly a hazard to property and people, and should be removed as soon as possible. The primary cause for concern is limb failure; due to the lack of canopy the tree is not likely to blow over, but the trunk or limbs could fail under their own weight regardless. The owner was advised of some issues related to the tree being on the property line, and she indicated she has already discussed the removal with the neighbors. The owner may provide or plant a new tree as part of the coordination effort. We recommend not planting a new tree in the same exact location, but four feet minimum from the fence on either side of it. Planting another poplar is not recommended. Soil may be treated with an antifungal drench prior to new planting, or 2 pounds of cornmeal per 100 square feet tilled into the soil.

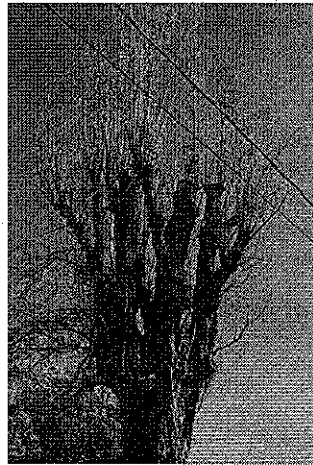
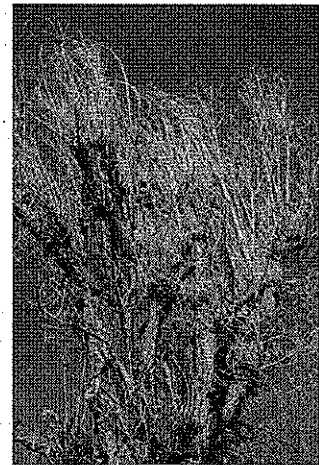
View from other side. No spring buds in evidence.

Large galls on trunk. Galls and wounds were weeping, indicating severe decay.

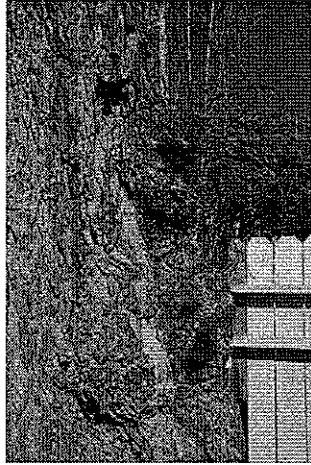
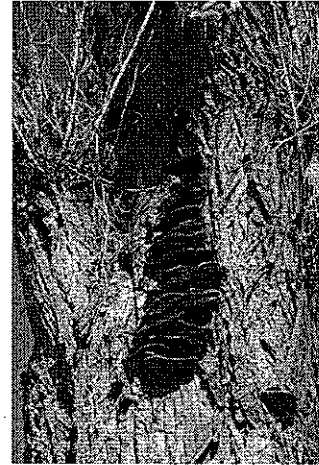
Large conchs on trunk. Conchs are visible all over tree in various sizes.

Conchs indicate severe fungal infection and decay. Tree trunk is essentially rotten - the interior of the tree is a very large cavity.

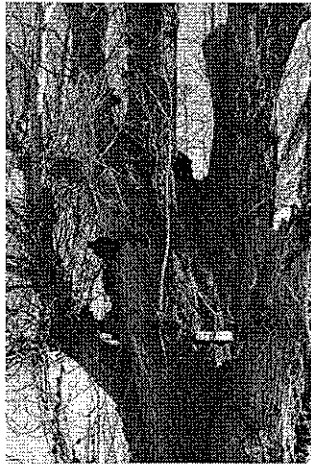
More conchs visible as dark lumps, broken branch stub at right, decay discoloration visible in stub.

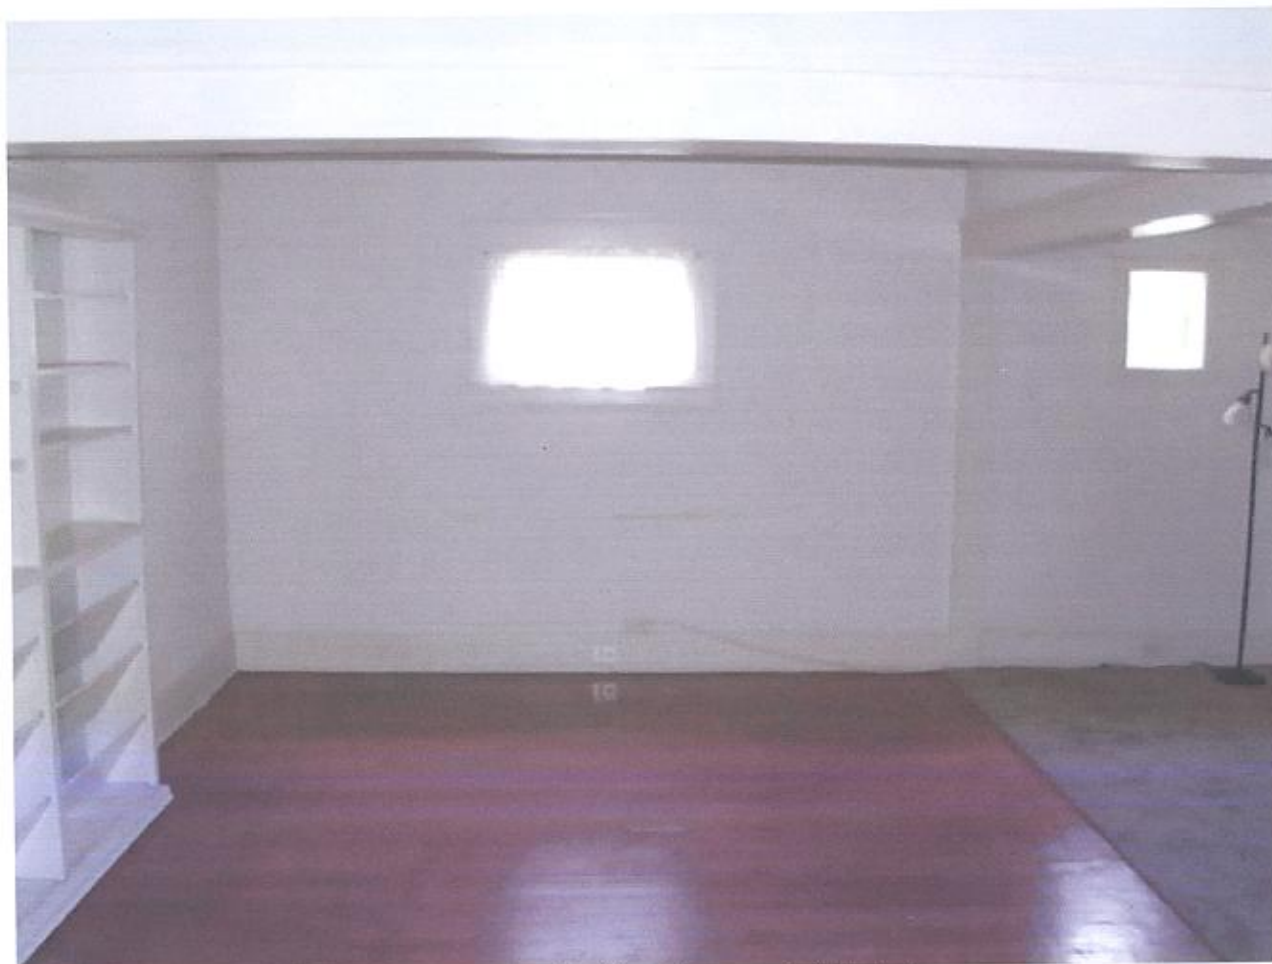
We removed the bookcases on the left and the carpet on the right, neither were original to the house.

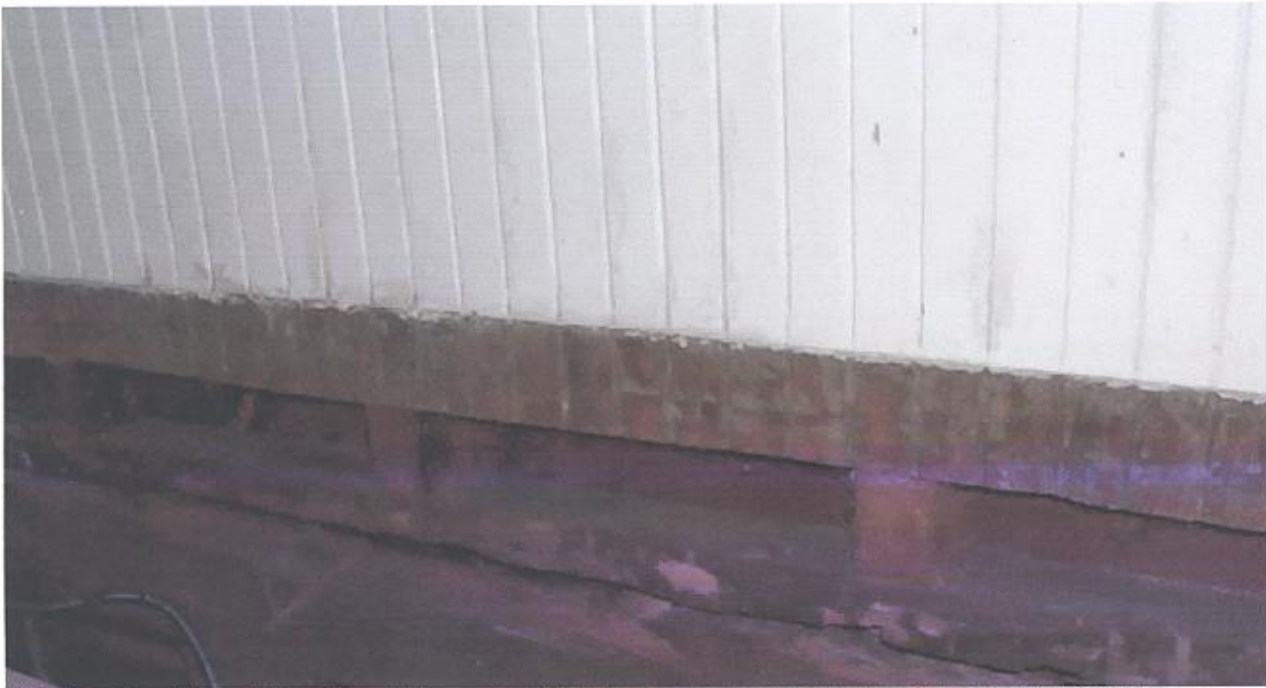
This photo shows the condition of the sub floor and wall in the laundry room as we were removing the boards that were unusable.

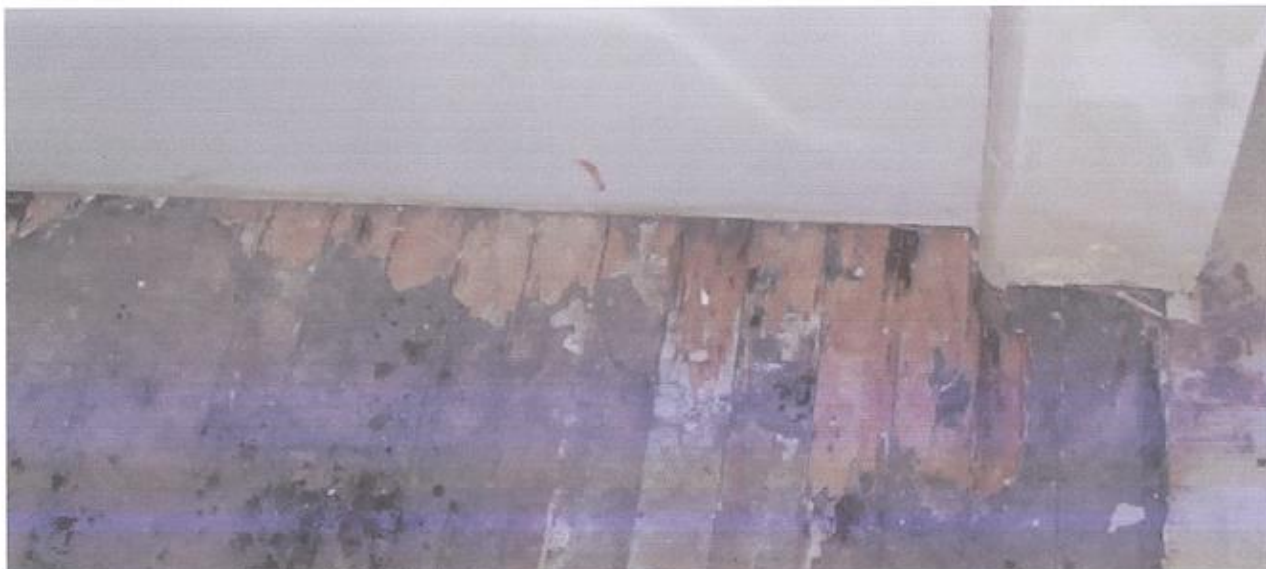
Termite damage under the vinyl flooring in the bathroom.

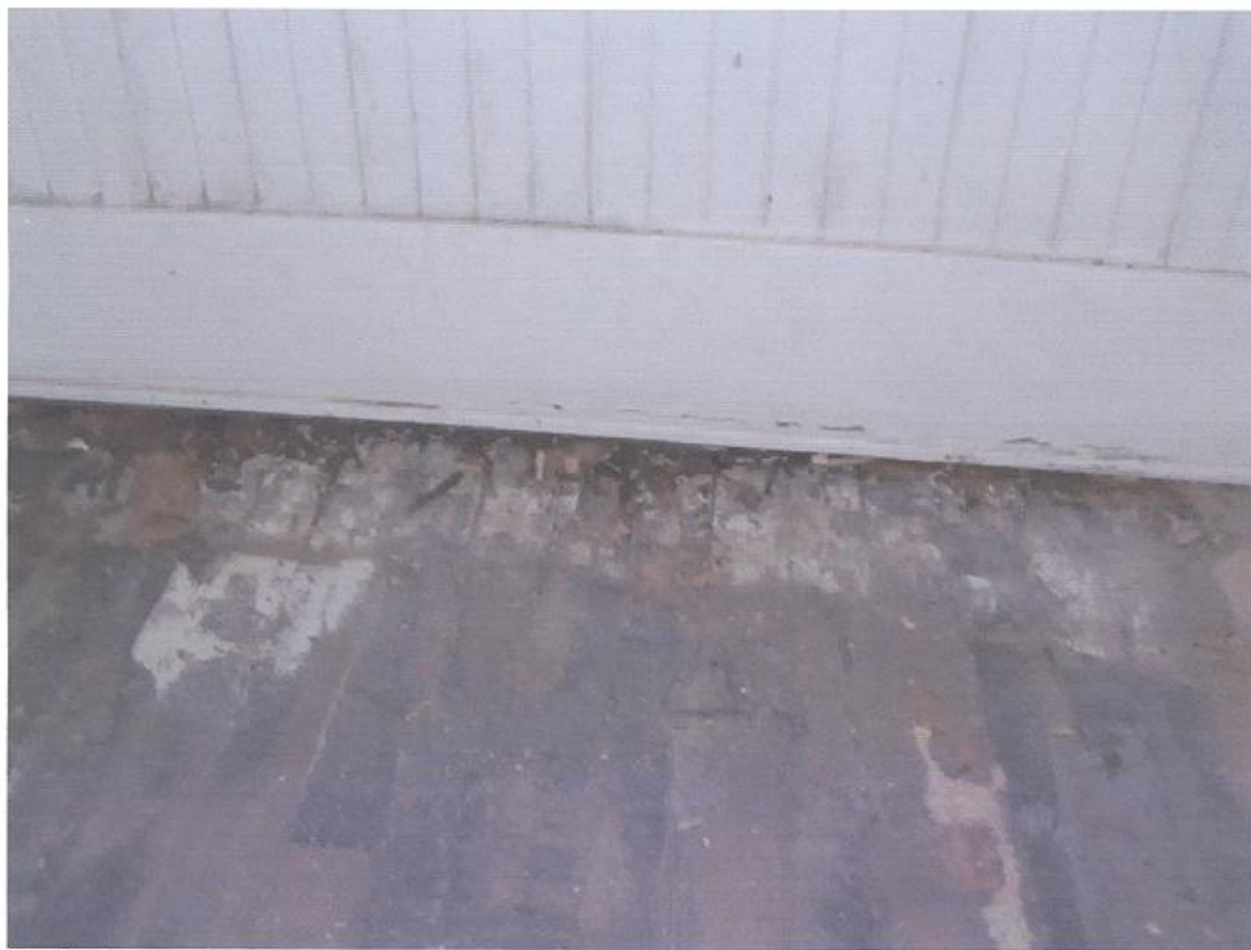
Termite damage

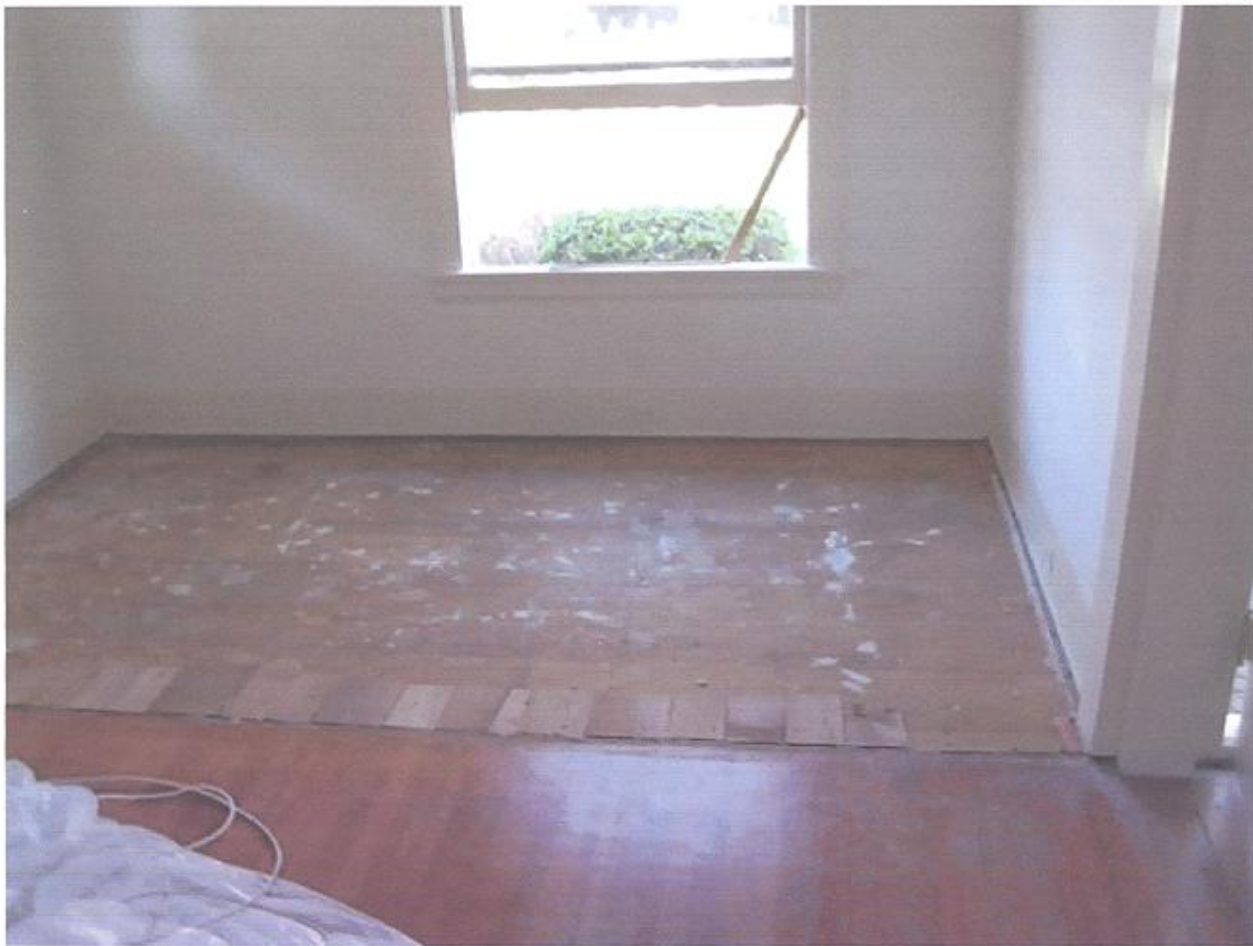
Termite damage
