Ventura County Grand Jury 2015 - 2016

Riverbed Hazardous Invasive Vegetation

May 3, 2016

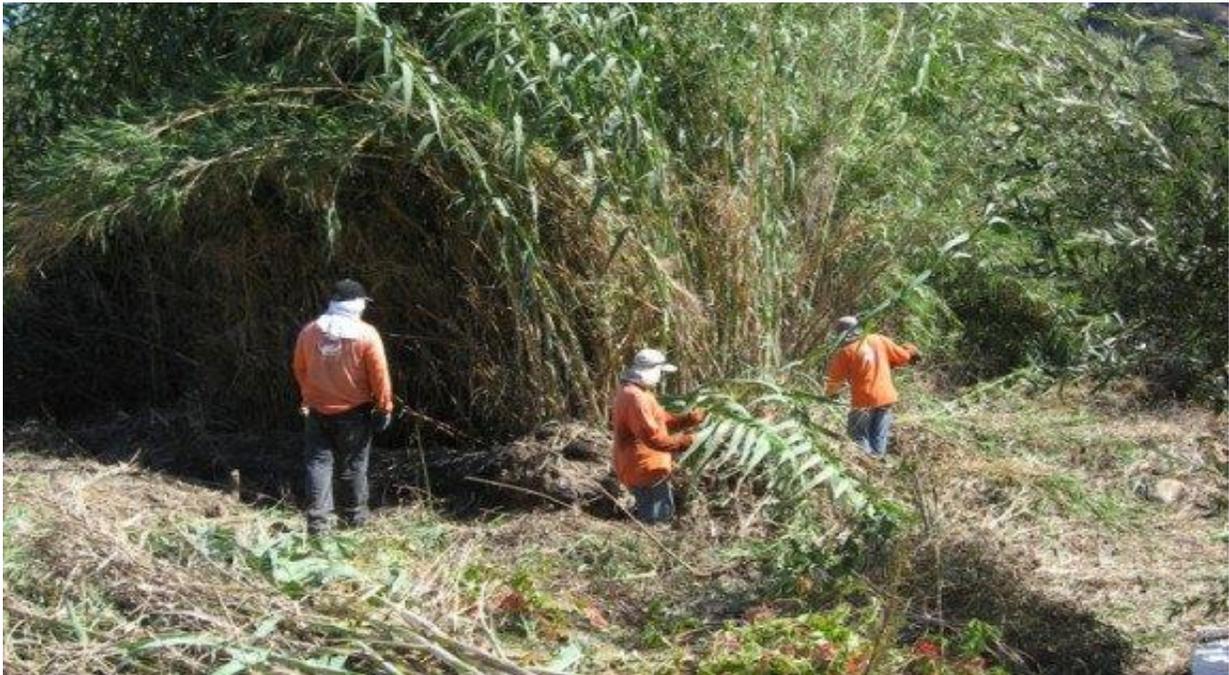
The Grand Jury learned that the presence of an invasive species of giant reed, *Arundo donax* (Arundo), is the major part of the problem. The Grand Jury conducted an investigation to determine the impact of this hazardous vegetation, the potential for infrastructure damage due to uprooted vegetation, and the actions being taken to control its growth in the Ventura County (County) watershed areas. (Figure 01)

Figure 01, *Arundo* growth. By permission of County of Ventura, Watershed Protection District

The Grand Jury recommends that the Ventura County Board of Supervisors take action to ensure continued, responsible access to the mountainous areas of the County where hydrology equipment is installed. In addition, the Board needs to develop plans and identify funds to limit the growth of Arundo and eventually rid the watershed of it and any other types of hazardous invasive vegetation.

R-01. The Grand Jury recommends that the Ventura County Board of Supervisors, in conjunction with the VCWPD, develop a long-term plan and corresponding budget line item that leads to the eventual eradication of Arundo. (FI-04)

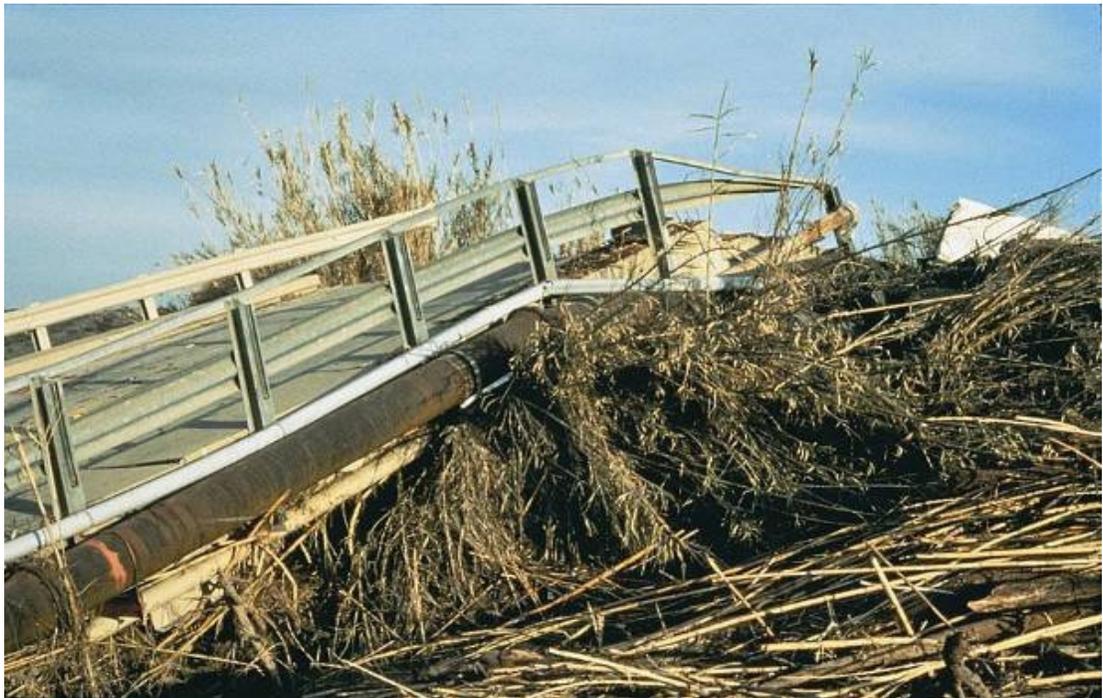
- FA-01.** The most recently available national data show 53% of bridge failures occur as a result of floods. Raging waters undermine bridge footings or batter the structures with debris and render them structurally weakened or destroyed. (Ref-01), (Figure 02)

- FA-02.** In southern California, the most hazardous watershed vegetation is an invasive species known as Arundo. This non-native plant can grow as fast as 4 inches per day and can reach 30 feet in height. Arundo is a major problem in riverbeds, estuaries, and beaches. It is often ripped out of the river bottoms by rushing storm water and washed downstream into flood control channels. It can form debris dams against bridges and culverts. Because the rhizomes (root mass) of this giant reed grow close to the surface, they often break off during rushing waters thus destabilizing the riverbanks, the leading cause of flooding in southern California. (Ref-02, Ref-03)

Figure 2, Bridge damage from Arundo dam (Photo from Ref-02)

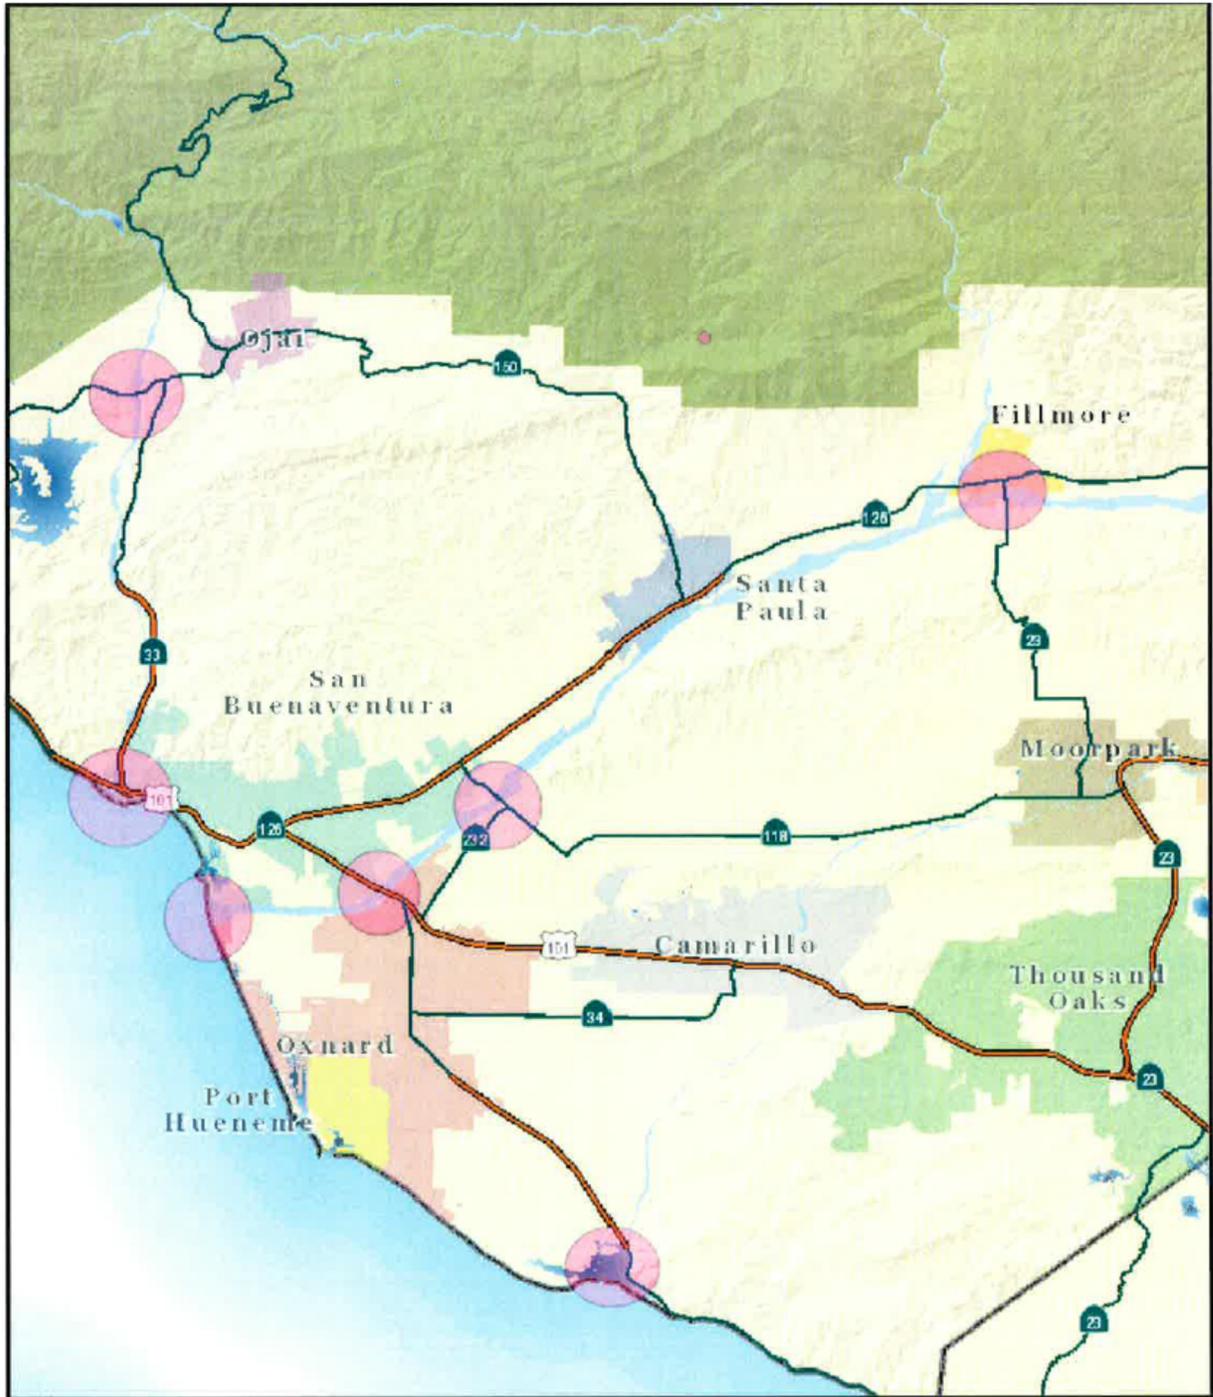
**Ventura County Map Showing Santa Clara and Ventura
River Major Bridge Crossings**

The Ventura and Santa Clara Rivers form a major portion of the Ventura County watershed system. Major highway and rail transportation arteries cross these two rivers at several locations. (Att-01) If this vital watershed system becomes clogged with debris and vegetation, a large storm could destroy these vital crossings and cause widespread inundation of the flood plains that border the two rivers.

Ventura Co. Bridges Hazardous Vegetation Printed: Jan 19, 2016

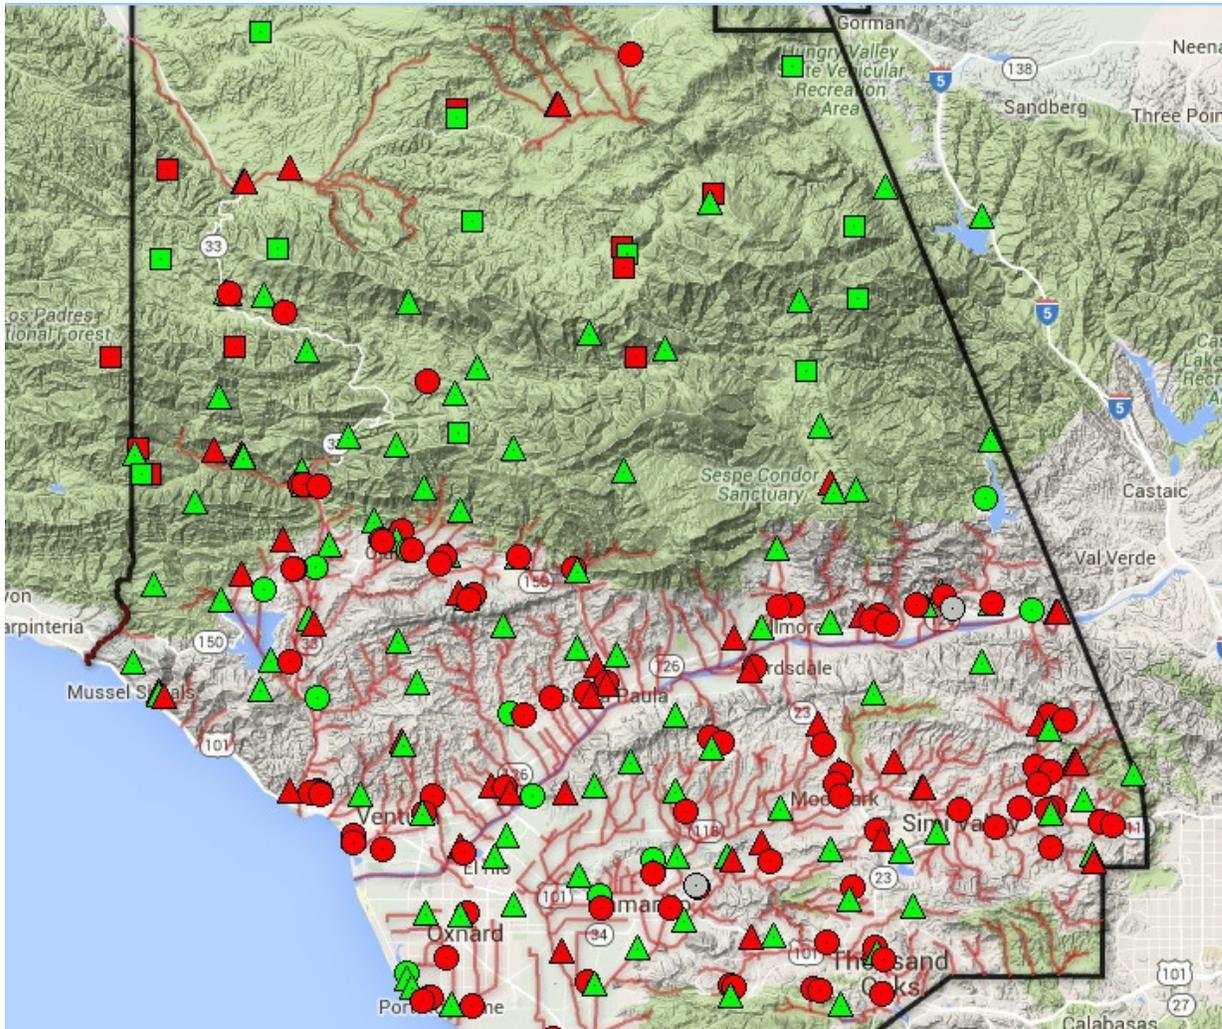
**Attachment 02
Ventura County Map Showing Hydrology Monitoring
Stations**

FA-07. The VCWPD maintains storm warning hydrology gauges throughout the County, including in the Los Padres National Forest. (Ref-08) (Att-02)

Ventura County Hydrology Monitoring Stations
Accessed 4 February 2016

R-03. The Grand Jury recommends that the Ventura County Board of Supervisors direct the VCWPD to negotiate a formal agreement with the U.S. Forest Service for continued responsible access to the Los Padres National Forest for the purpose of installing and maintaining hydrology equipment. (FI-04, FI-05)
